Wetland Permitting for a Rail Trail: **The Danvers Experience**

Kate Day & Charley Lincicum
November 8, 2014
Mass Trails Conference

Danvers - Topsfield Connector Border-to-Boston Trail

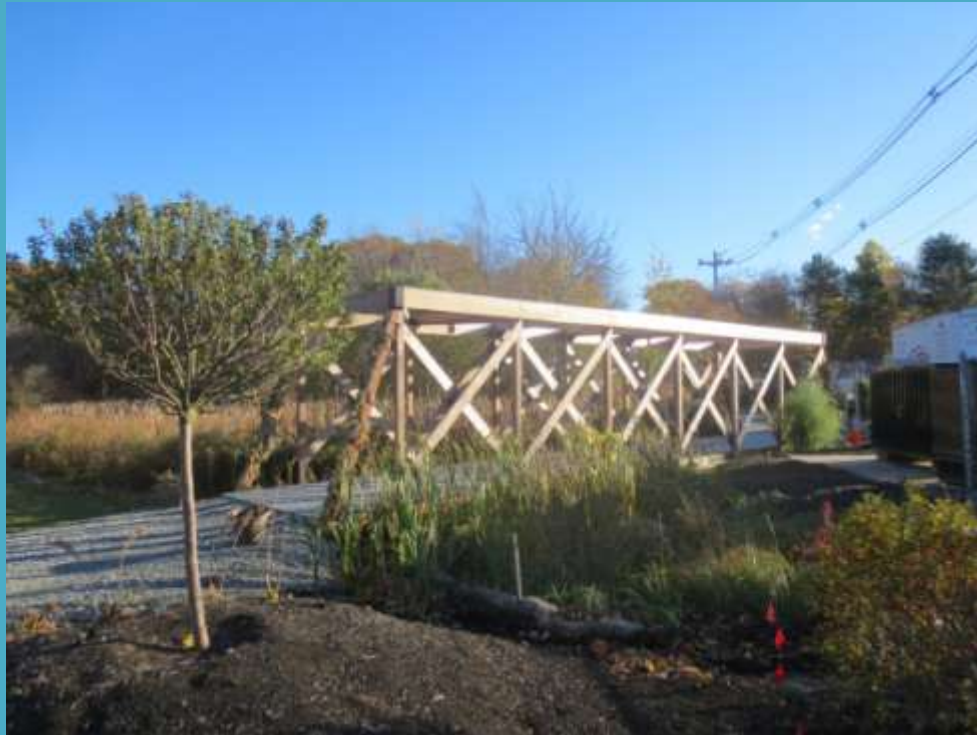
BRIDGE OVER WETLAND CONSTRUCTED UNDER ORDER OF CONDITIONS

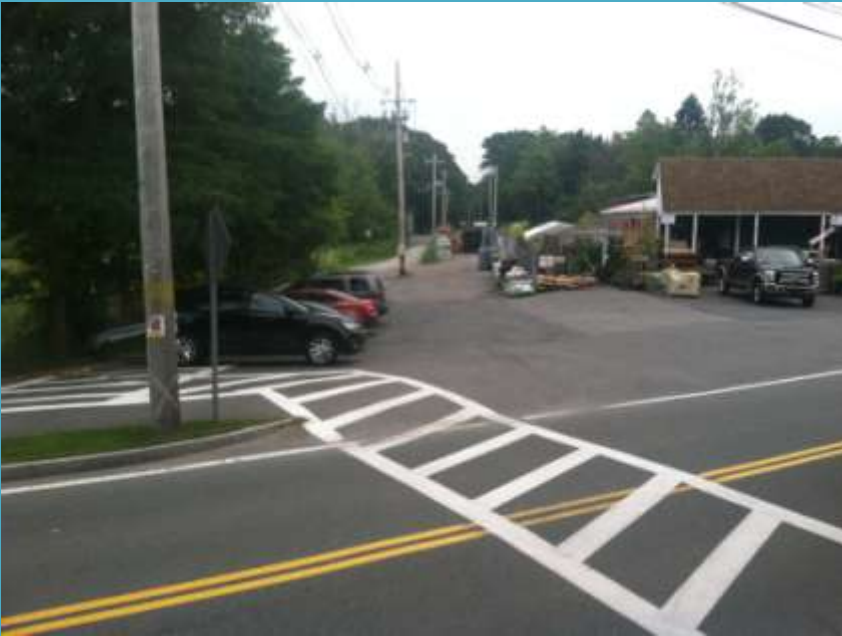
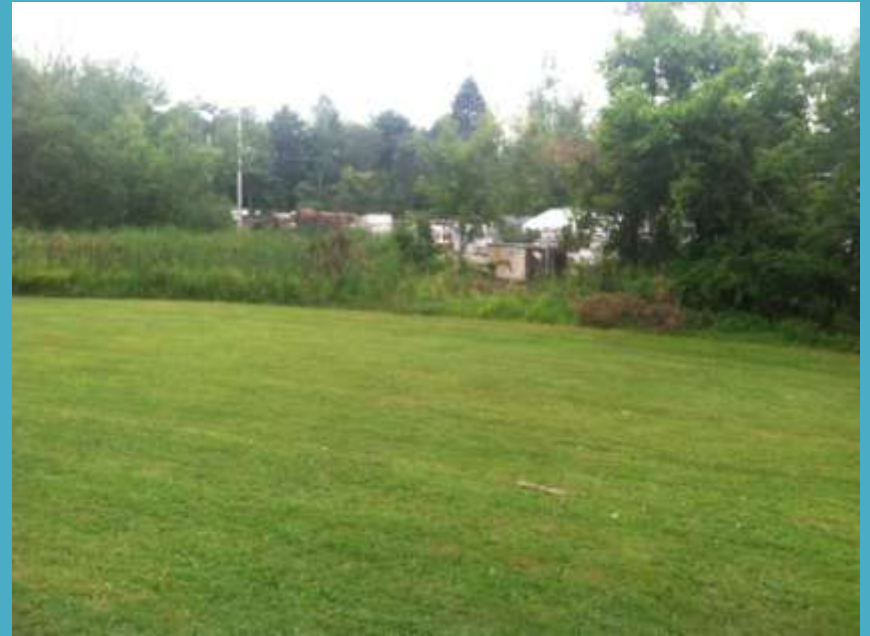
RAIL TRAIL CORRIDOR POSED SAFETY PROBLEM

**ORIGINAL CORRIDOR THROUGH PARKING LOT, ADJACENT PARK
OFFERED OPPORTUNITY TO CREATE ALTERNATE ROUTE**

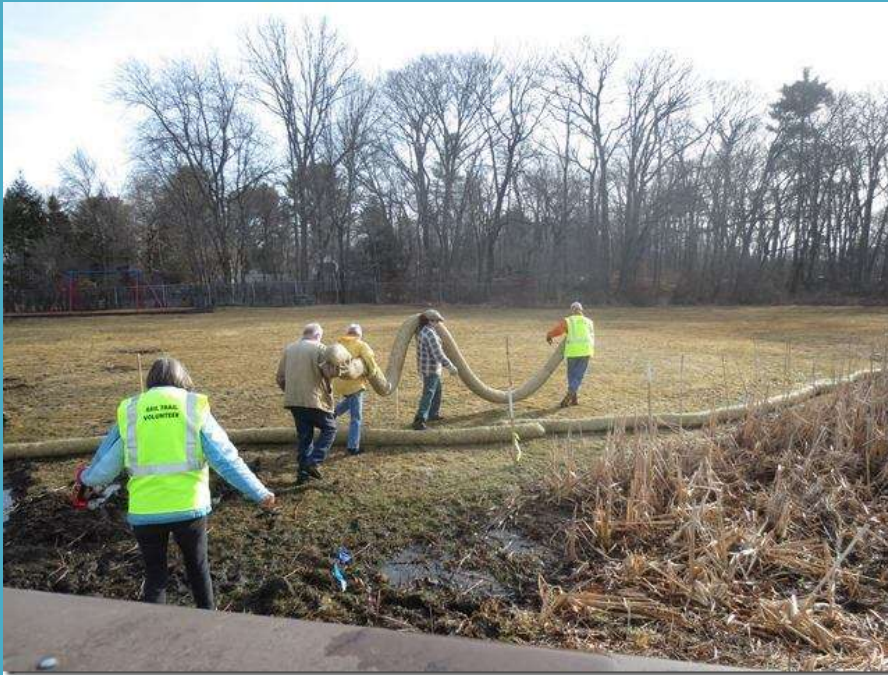
CONSTRUCTION PROCESS:

**WORKED CLOSELY
WITH CONSERVATION
STAFF TO MAKE SURE
ALL CONDITIONS
SATISFIED AND BEST
PRACTICES USED AT
ALL TIMES**

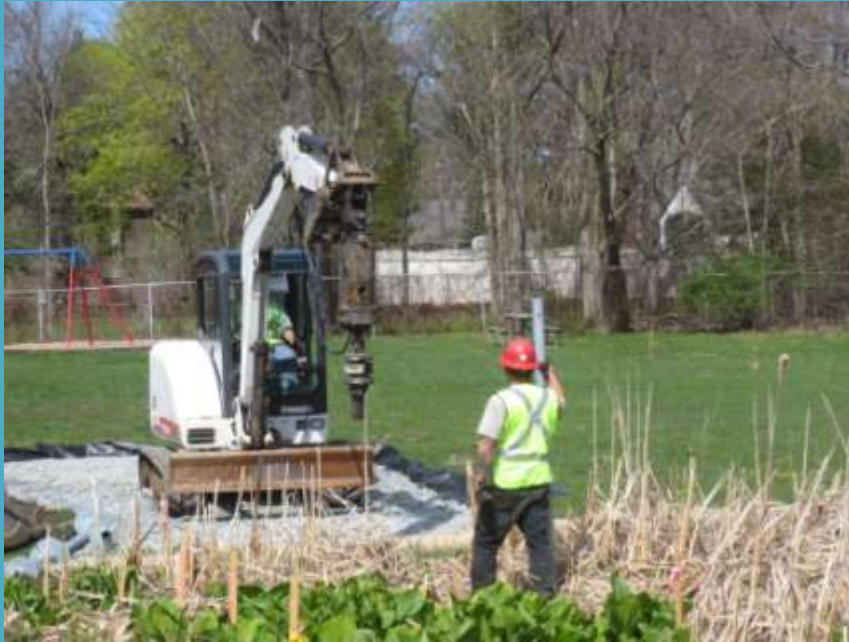
**HELICAL PILES USED AS BRIDGE
FOOTINGS, MINIMAL INTRUSION
TO WETLAND AREA DURING
CONSTRUCTION PHASE, A MAJOR
PLUS IN PERMITTING PROCESS**

- 42' bridge over wetland constructed
- Use of helical piles minimized impact, assures longevity of materials
- Expansion of wetlands into previously mowed area twice the square footage of bridge
- New bridge/trail blocks Agway from plowing snow into wetland area
- Safe passage through park for trail users

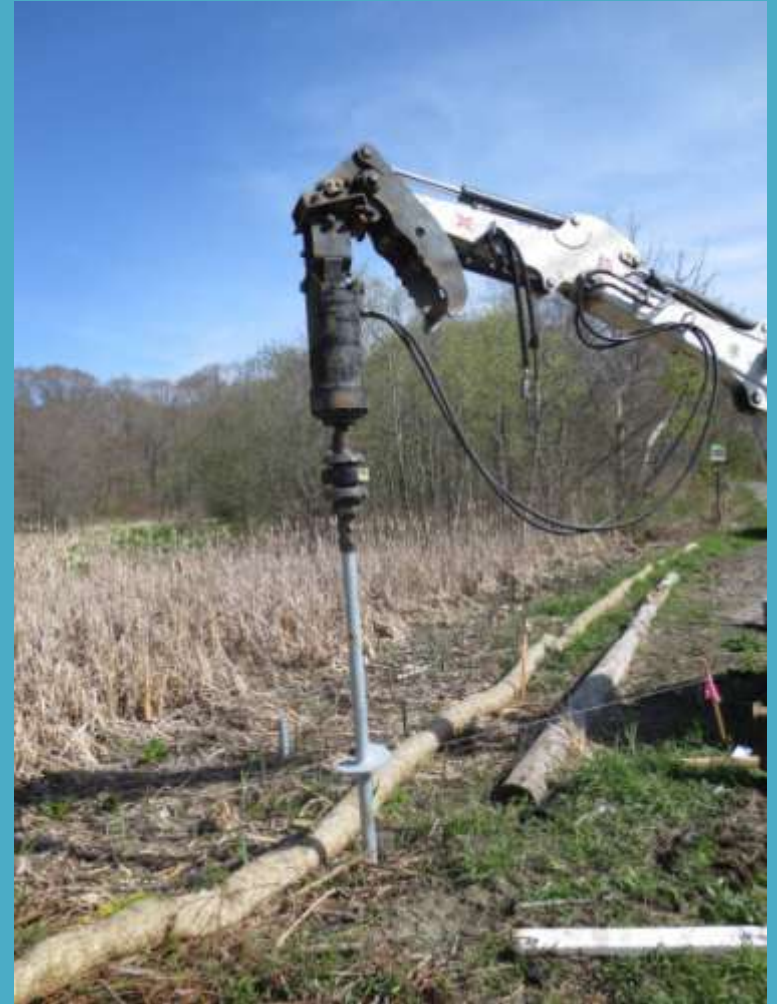
**FRAMING OVER HELICAL
PILES QUICK AND EASY,
MINIMIZING TIME AND
IMPACT ON WETLAND
CROSSING**

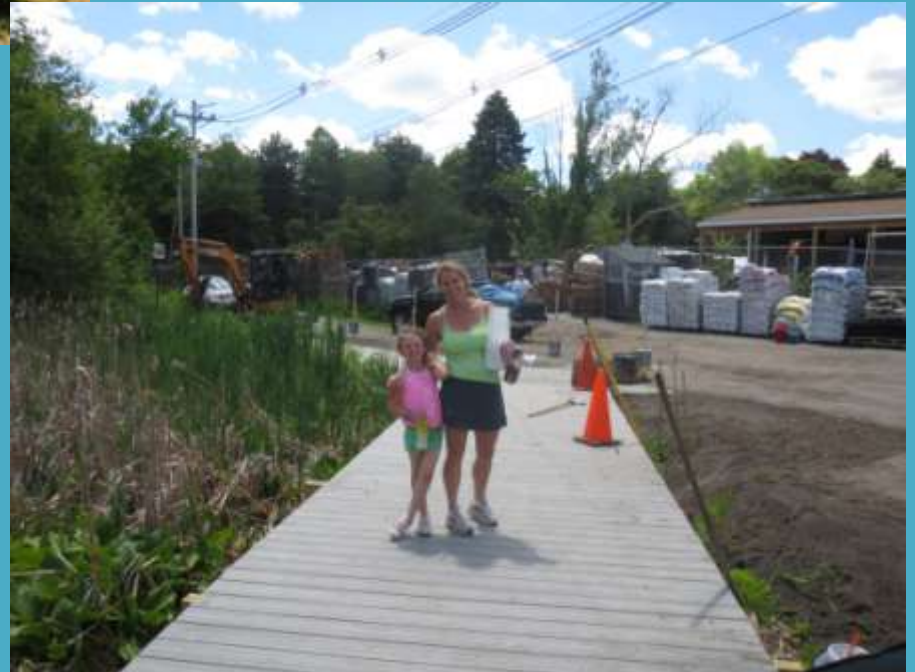
**TREX DECKING USED FOR
MAXIMUM DURABILITY OF
SURFACE, SPACING OF
DECK BOARDS ALLOWS
LIGHT PENETRATION INTO
WETLAND BELOW**

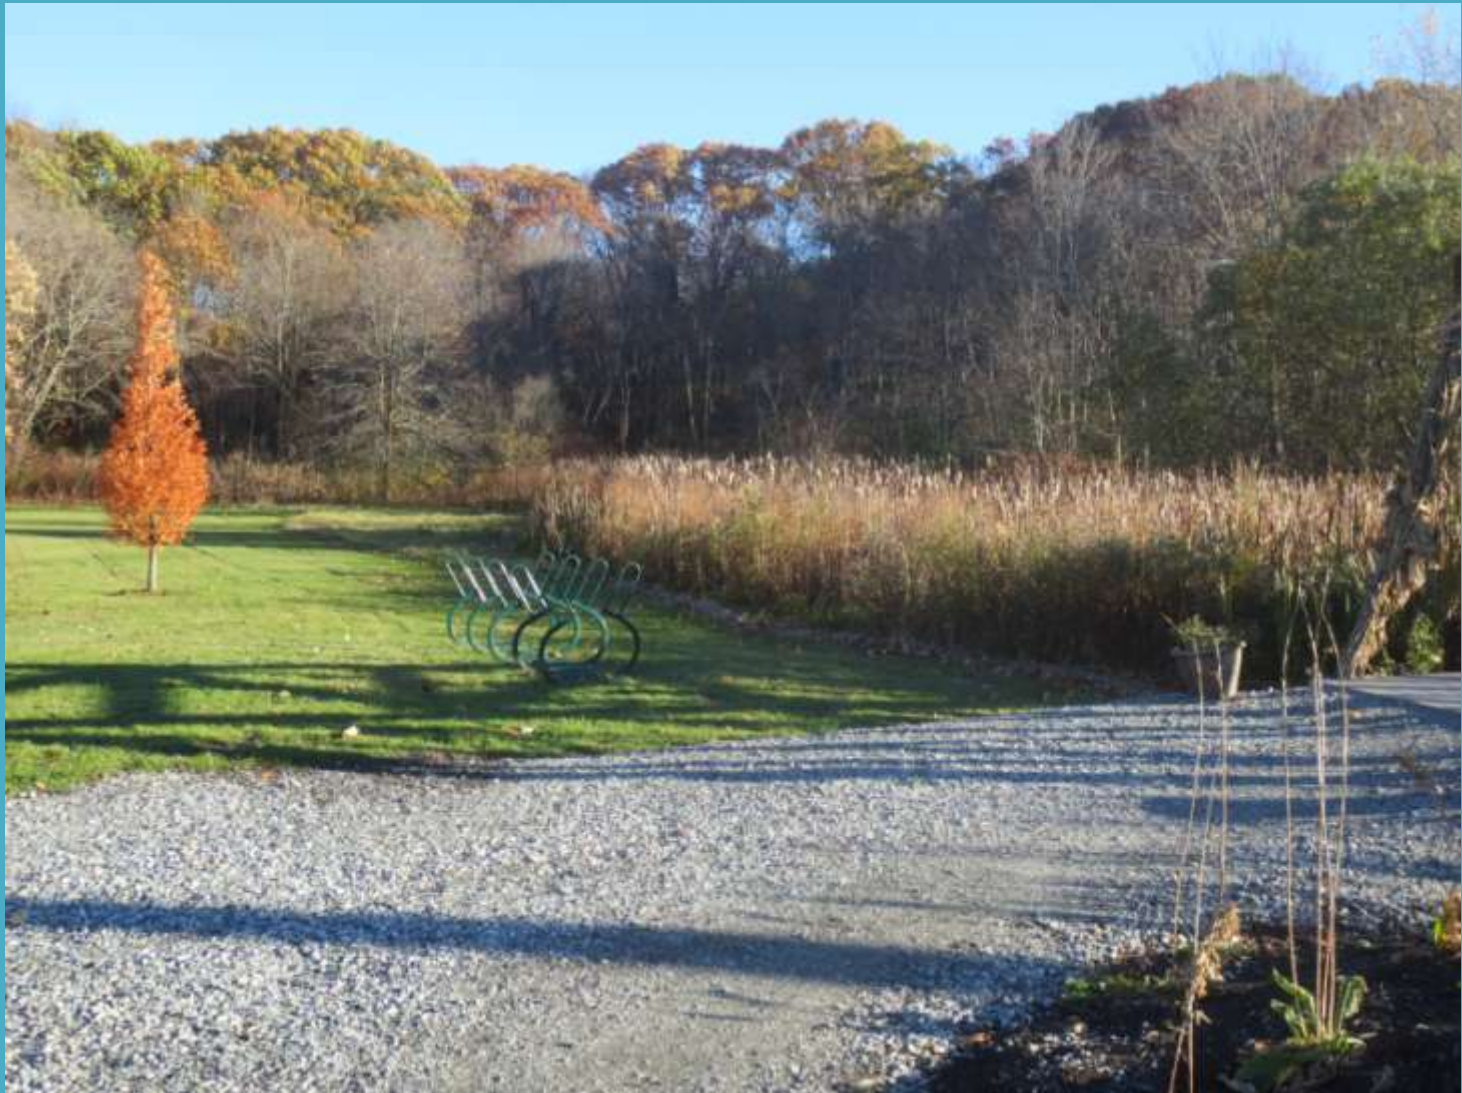
**NOTE NEW GROWTH ADJACENT TO CAT TAILS –
ALLOWING WETLAND VEGETATION TO GROW FURTHER
INTO AREA PREVIOUSLY MOWED BY DPW**

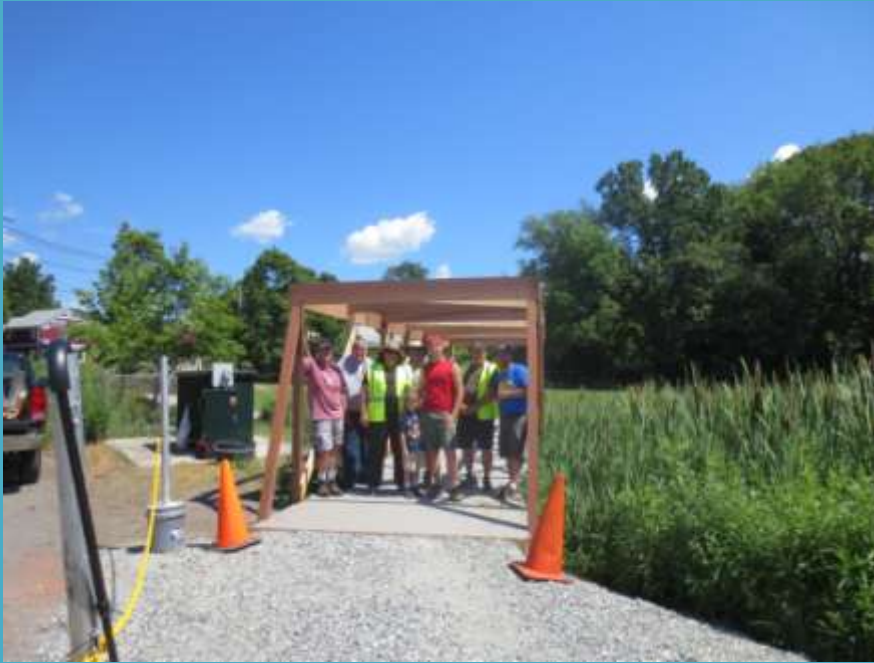
**EAGLE SCOUT
PROJECT ADDED
RAILINGS IN “TRESTLE”
STYLE**

**COMPLETED
BRIDGE SITS 18”
TO 2’ ABOVE
WETLAND**

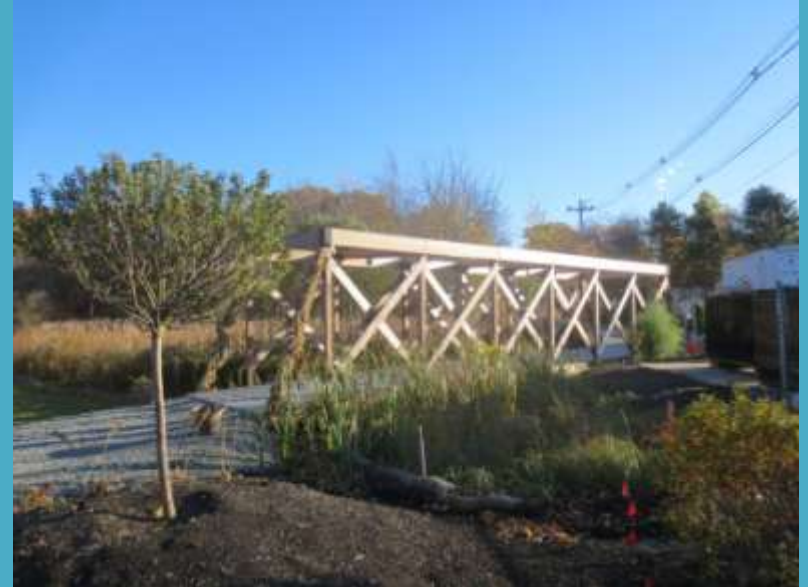
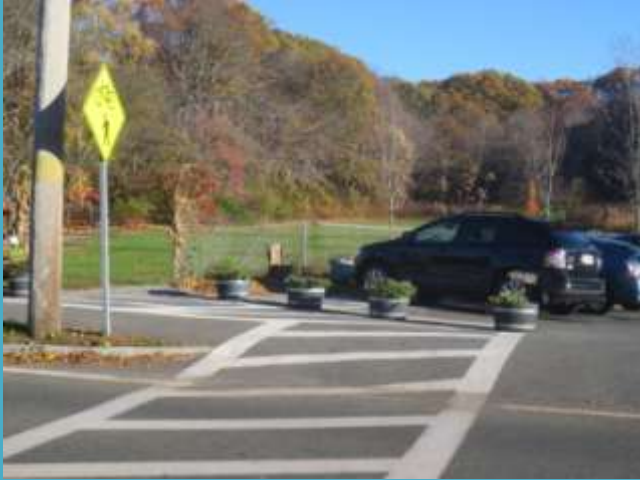
**RE-ROUTING TRAIL HAS REVITALIZED
AN UNDERUTILIZED PARK;
BRIDGE PROVIDES SAFE PASSAGE FOR
TRAIL USERS**
